Rajiv Nagar Higher Primary School

Vijayapura, Karnataka

Intervention: Rainwater Harvesting with improvement in water and sanitation infrastructure

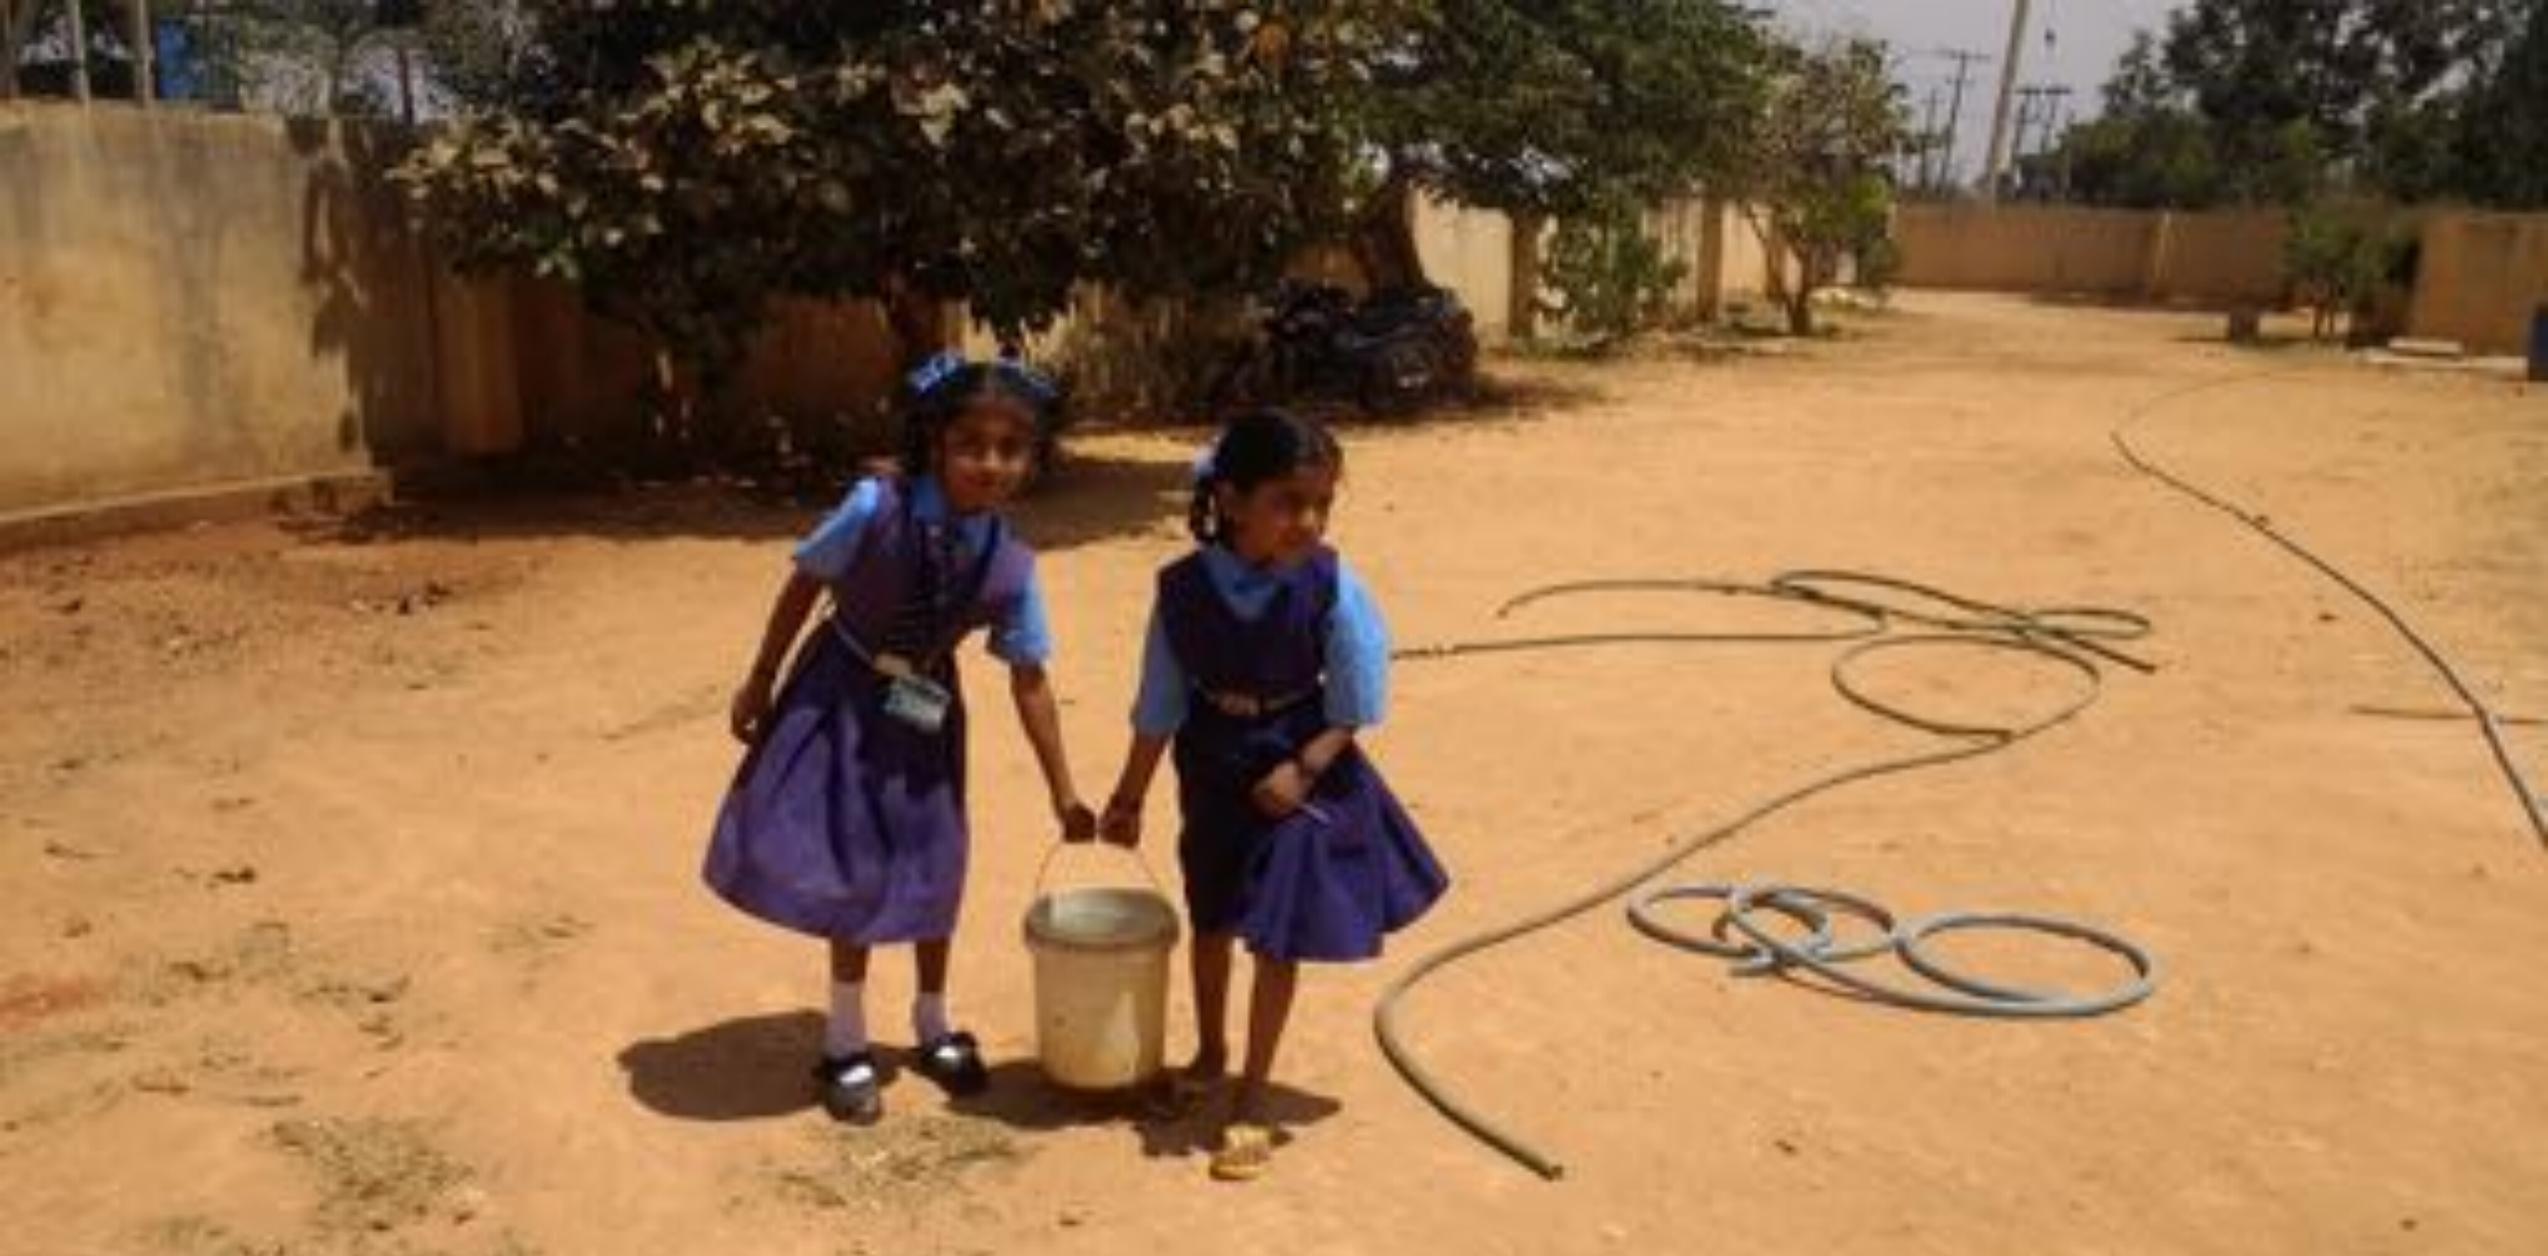
Water needed to be carried: Students carrying the water in buckets for toilets

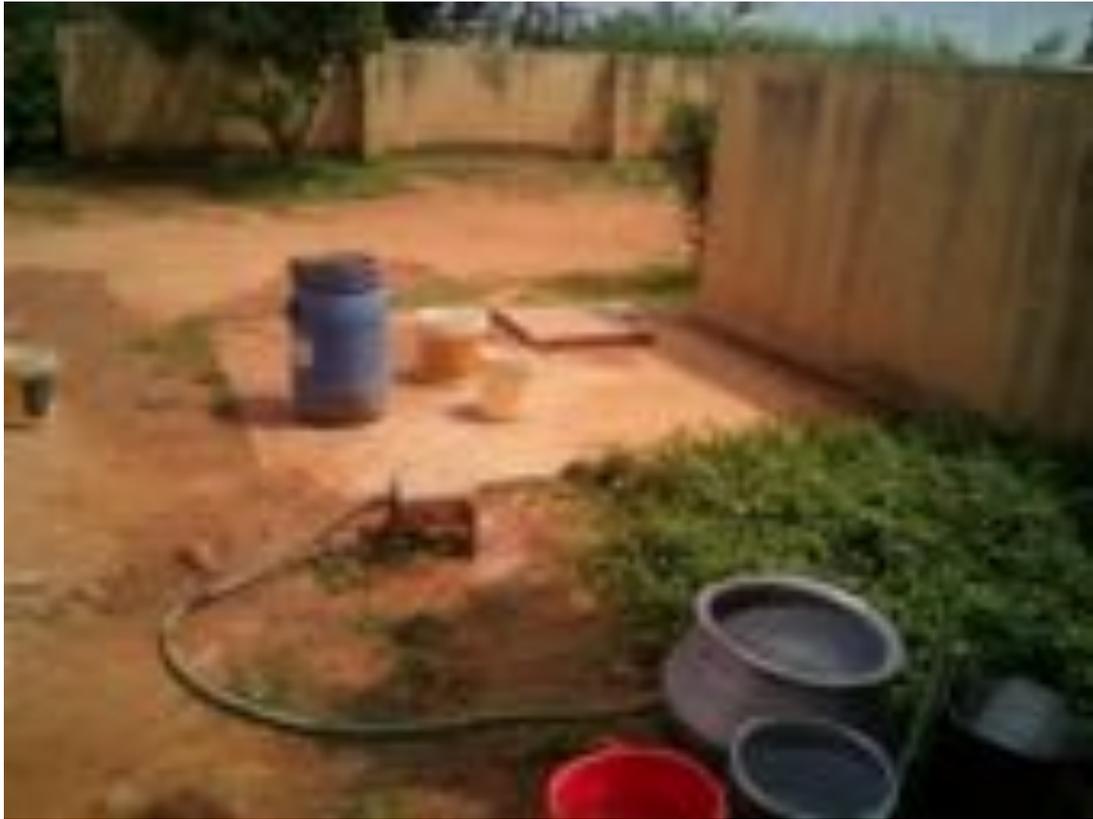
No provision of OHT, water needed to be stored in small storage containers

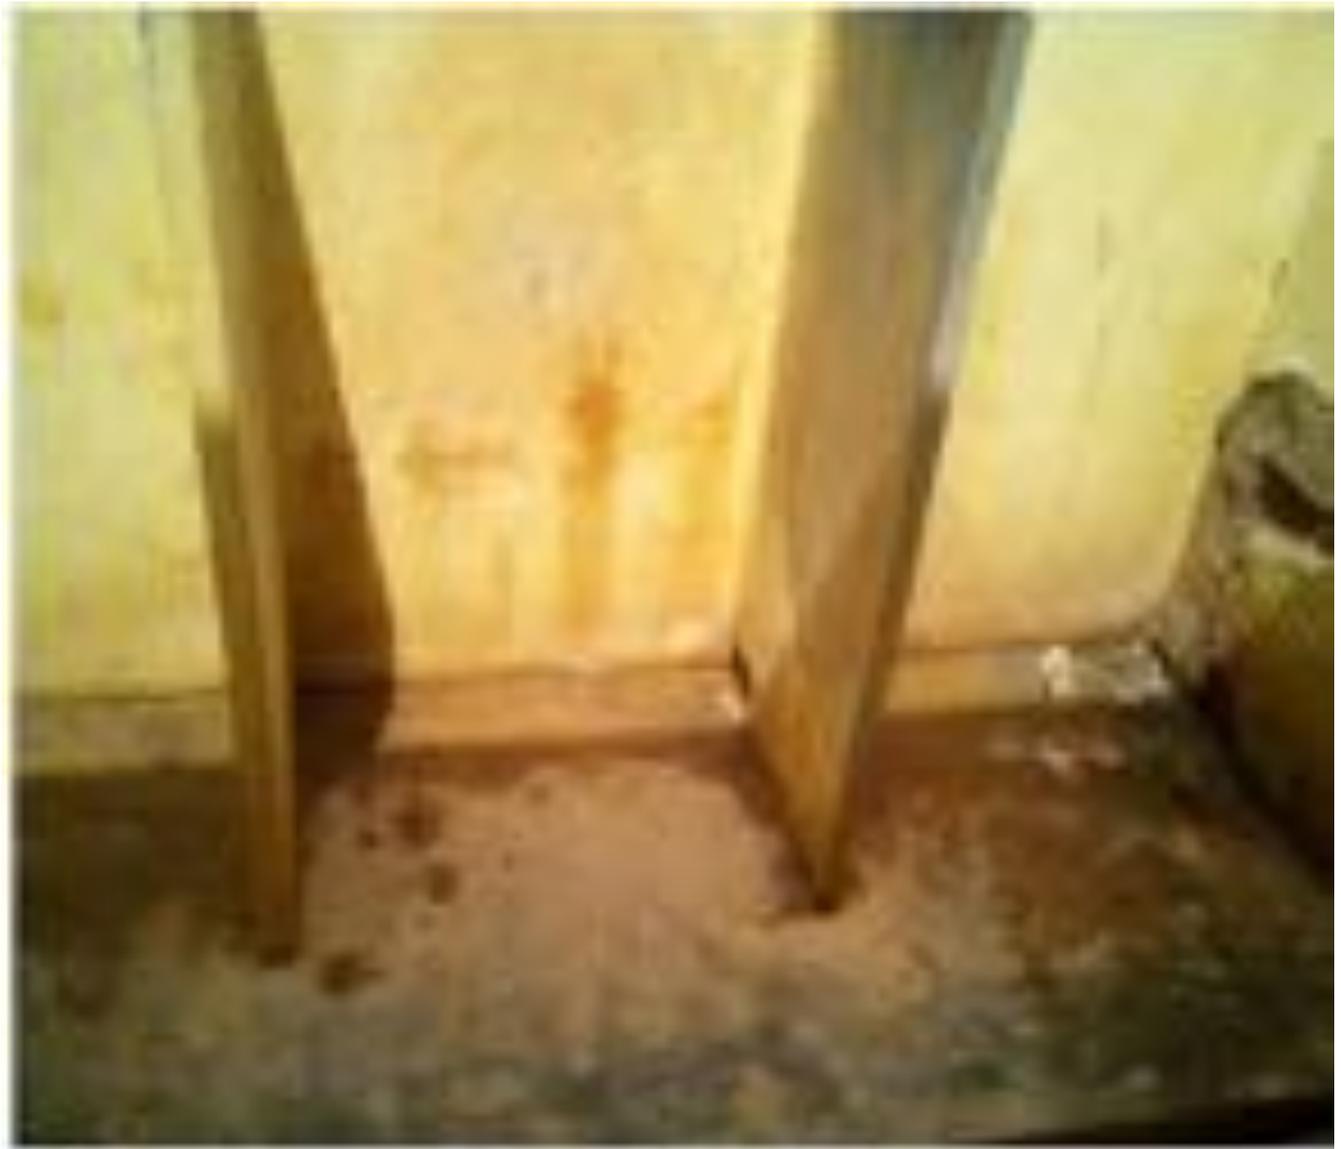
Urinals without appropriate drainage

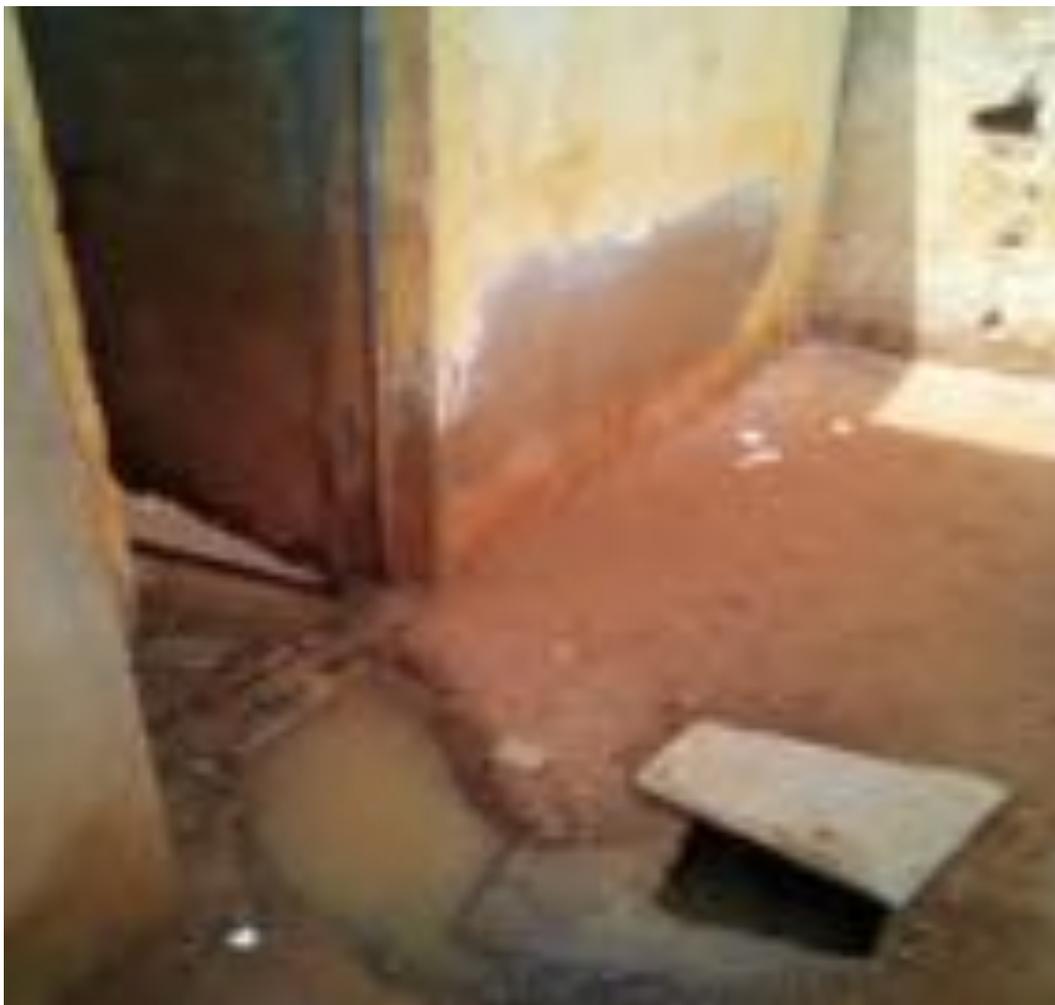
Water stagnation near toilet blocks, Broken toilet door

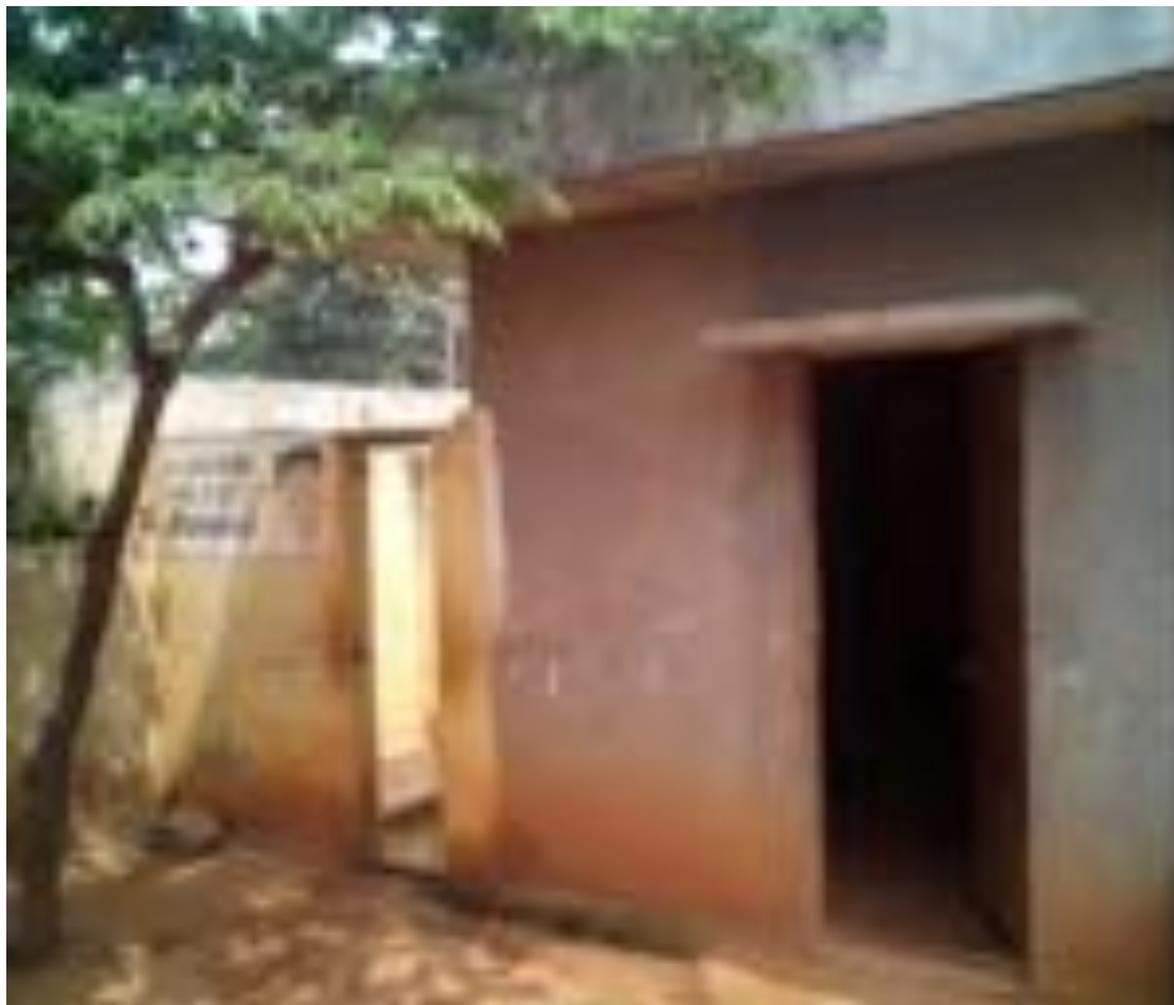
No plumbing to the toilets

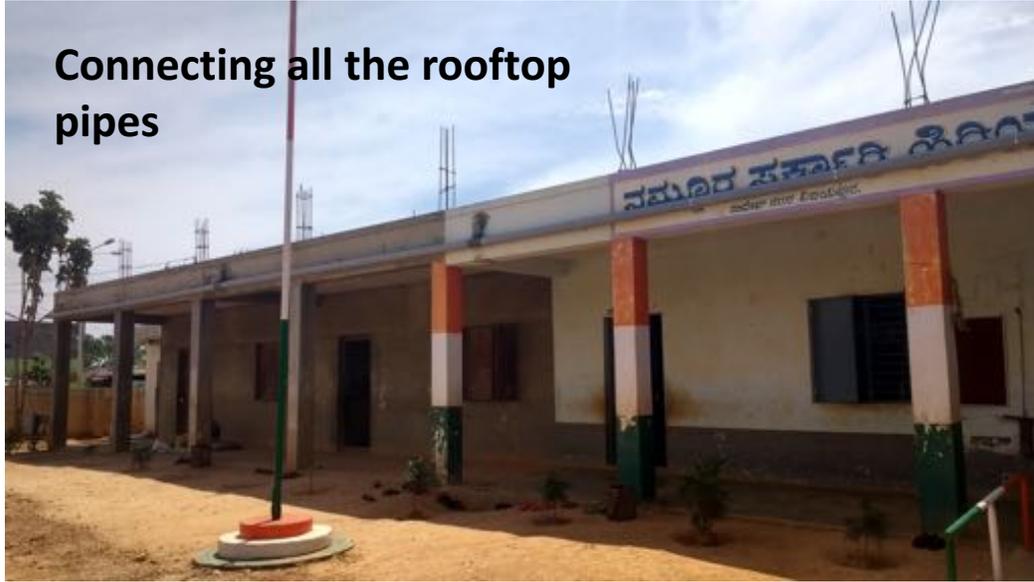
Connecting all the rooftop pipes

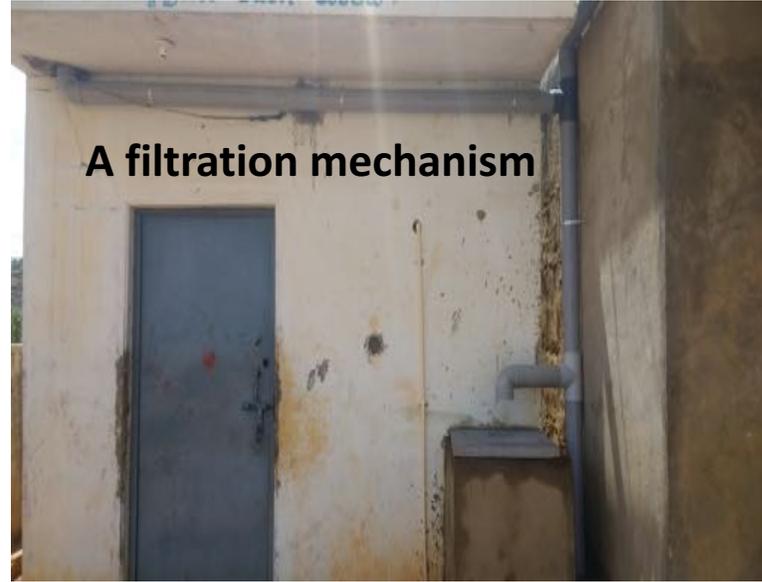
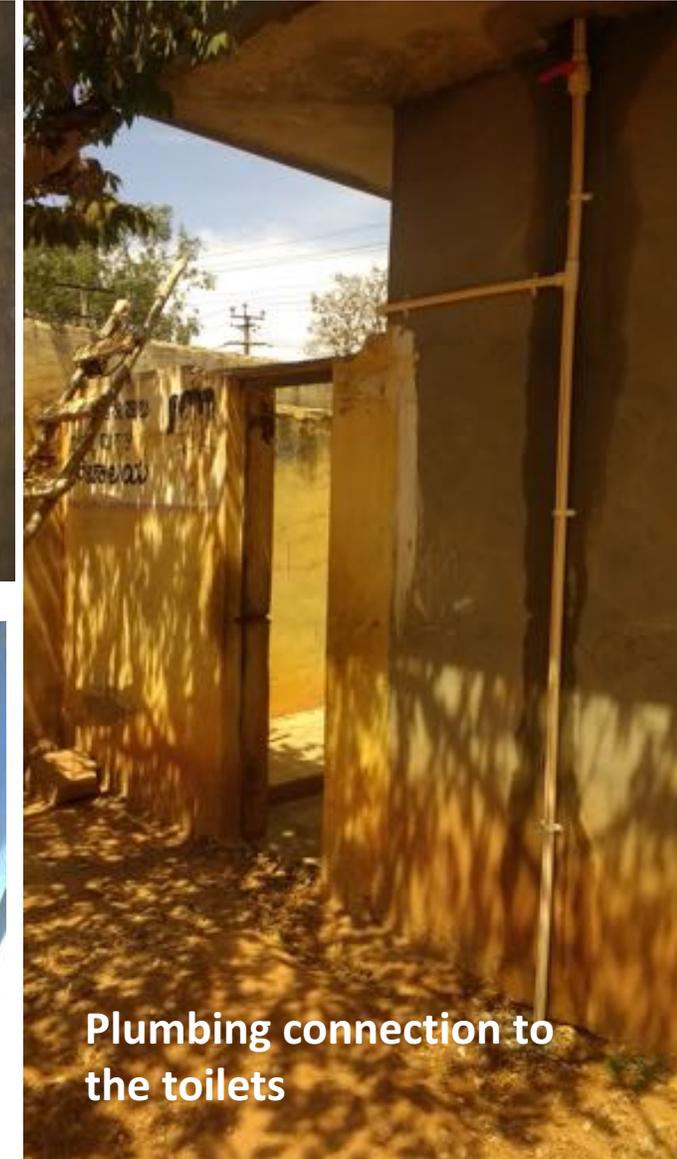
A filtration mechanism

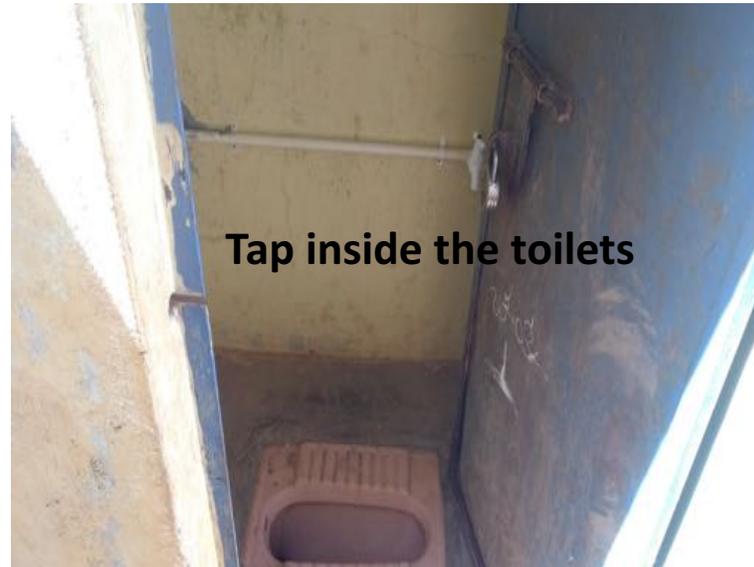
Tap inside the toilets

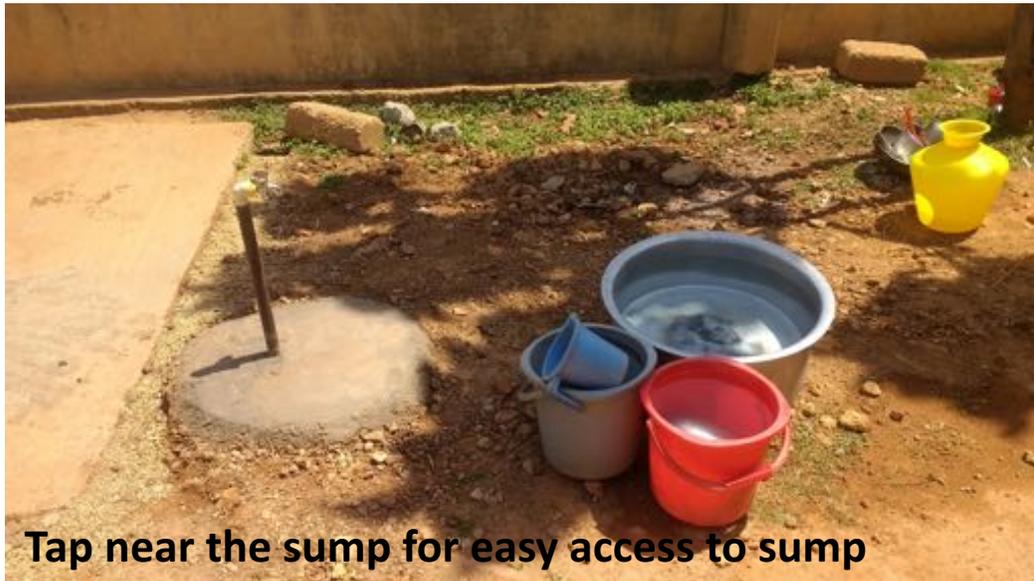
Tap near the sump for easy access to sump

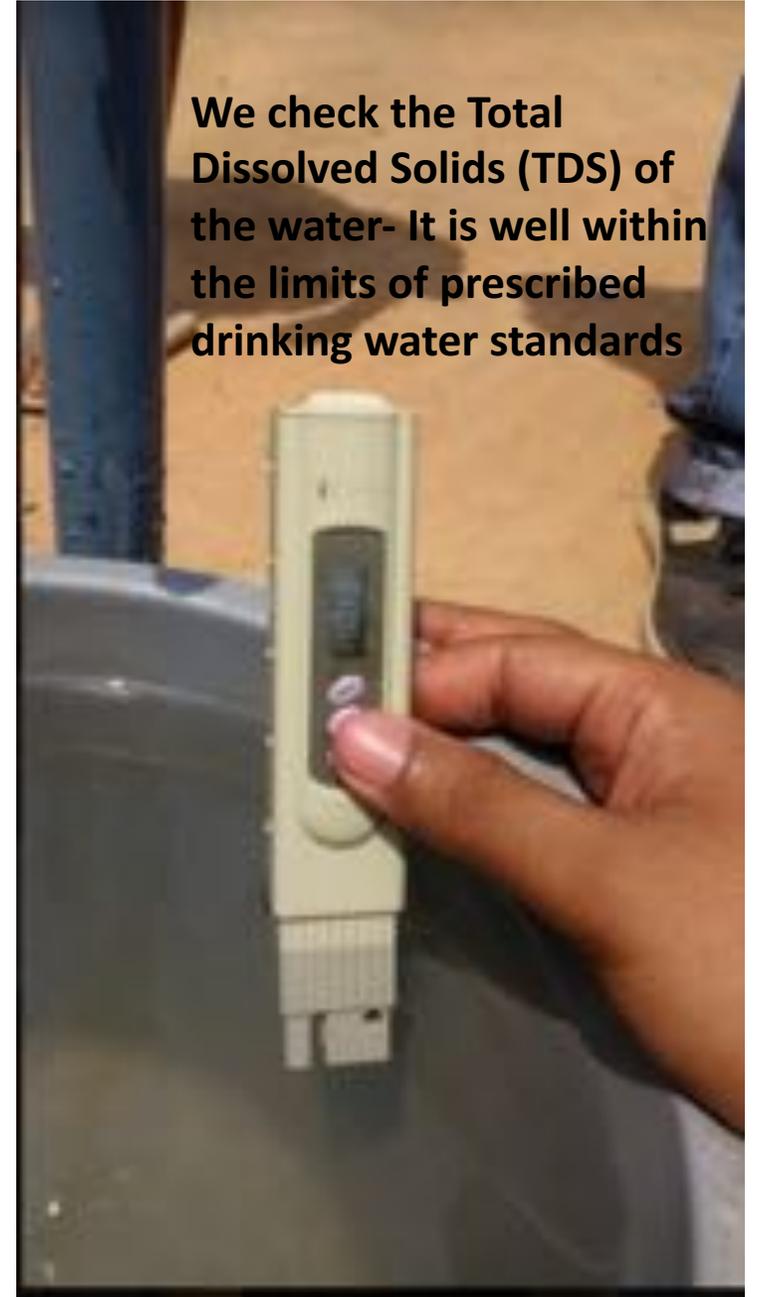
We check the Total Dissolved Solids (TDS) of the water- It is well within the limits of prescribed drinking water standards
